Repair of sewage manholes

**Abstract of the
final report (274 pages) on the research project:
Repair of sewer manholes
by the IKT – Institut für Unterirdische Infrastruktur, D – Gelsenkirchen –
(Institute for Underground Infrastructure)**

**This summary should serve as a
quick and simple overview
on the testing procedures and test results
for XYPEX
distributed by BAWAX GmbH/Germany.**

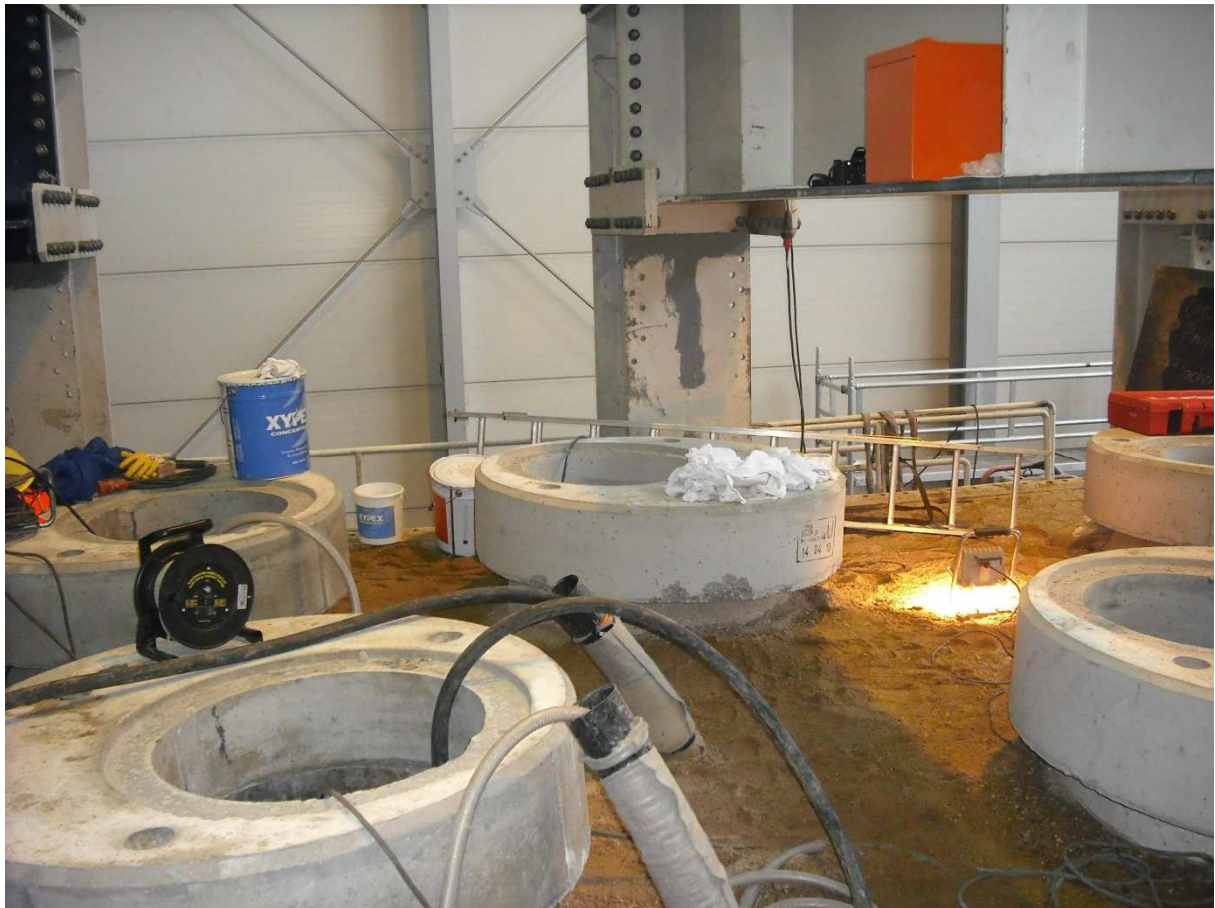
Photo 1: Experimental setup of the shaft systems in large-scale test stand

On a large-scale test station of the IKT comparative studies for all sealing and coating procedures were carried through in a relation 1 : 1 under defined and equal ambient conditions. The core of the large-scale test stand was a steel tank of 15 m length and 6 m width and height respectively. As part of the project, 20 manholes made of precast concrete were installed in a gravel-sand mixture with a maximum particle size of 8 mm and tested under varying water pressures. 11 manholes were provided for coating action. Another 7 were sealed by different methods. Two shafts were used as pumping wells for dewatering of the system.

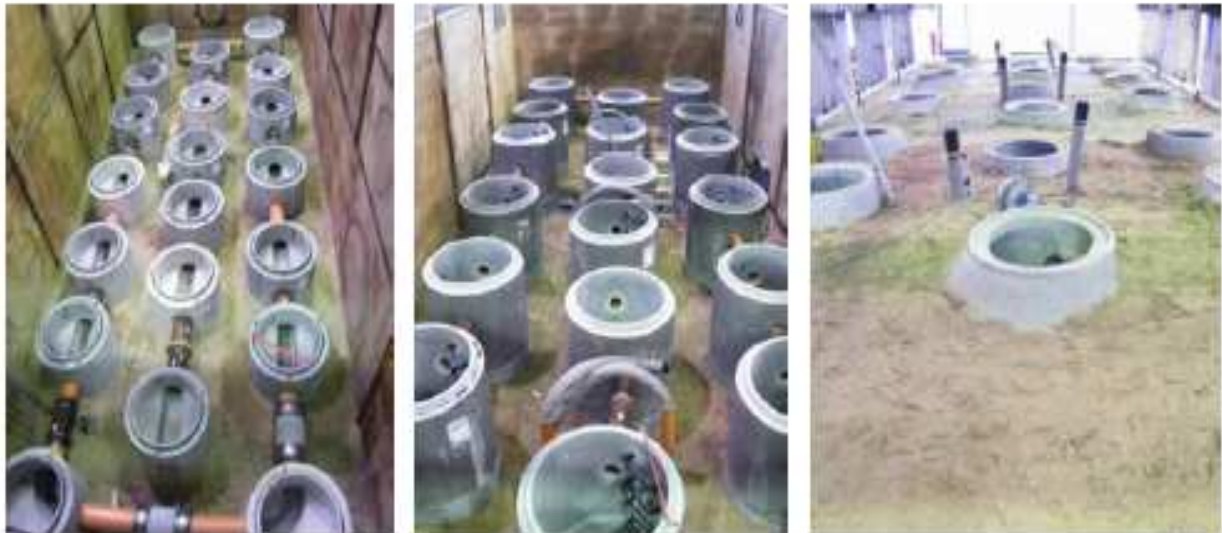
Photo 3: Installation of shafts in the test series as:
Lower pipe layer DN 300 (left); medium pipe layer DN 150 (center); completed installation (right)

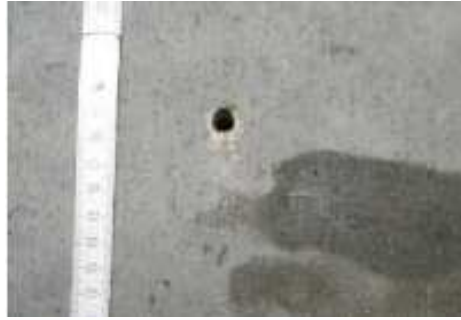
Damage (Abbreviation)	Number of drilling holes	Diameter of drilling holes	Pictures of the damaged areas
"Local injury " (LS)	each 1	10 mm

Before and during installation of the precast concrete elements, each different slot ring was exposed to damaging conditions. These simulated local and surface leaks as well as leaking manhole joints. Mainly holes in different sizes and numbers were drilled. There were three different damage types as shown in Table 2. Each precast concrete element in the shafts was provided with two damaged areas.

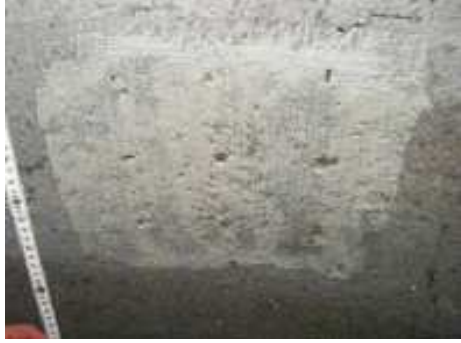
"Surface leakage" with a release agent (FU)	each 9	9 mm

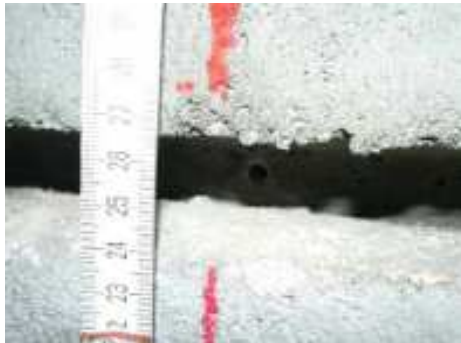
„Damage to man- hole joint“ (SF)	each 4	6 mm

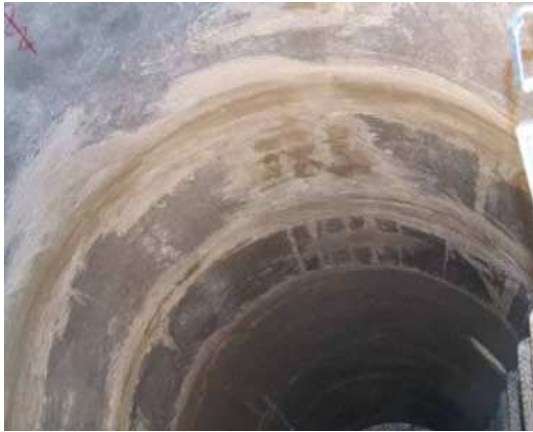
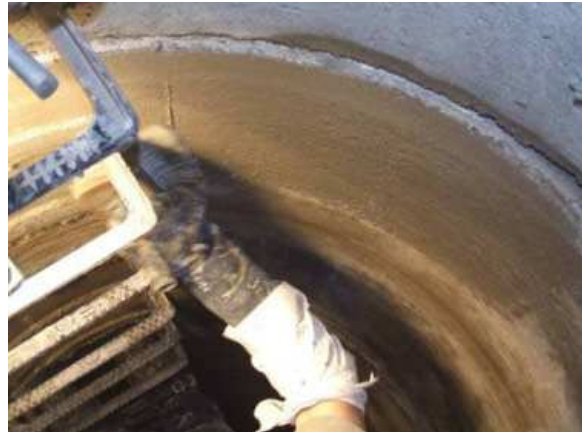
Photo 5: Sealing with crystallization mortar: backfilled annular gaps in the shaft wall (left); application as slurry coat with a wide brush (right)

1. Stopping of heavy water ingress by using the XYPEX PATCH'N PLUG;
2. Re-profiling of ring joints and fractures in the shaft wall
(see photo 5, left);
3. Application of the crystallization product or mortar XYPEX CONCENTRATE as slurry coat to the shaft wall from top to bottom
(see photo 5, right).

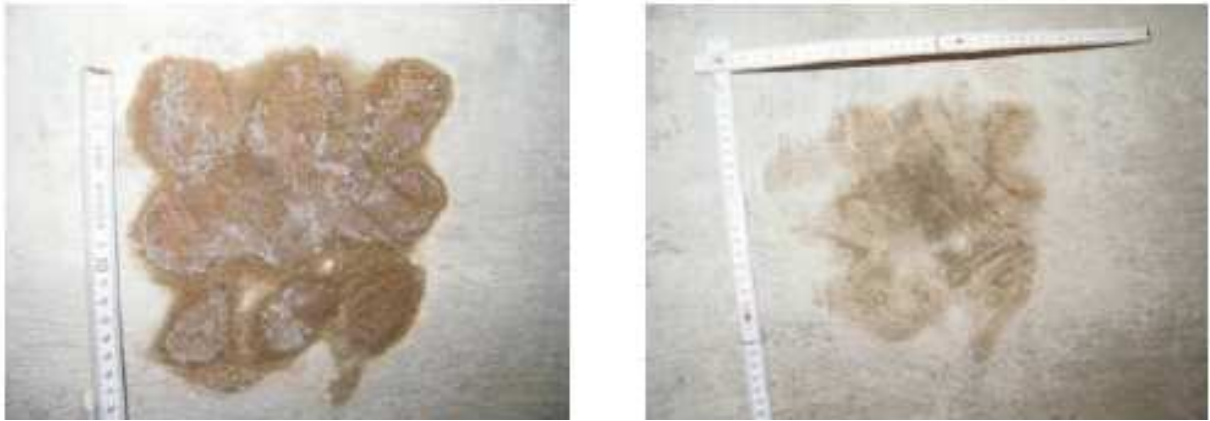
Photo 6: Change of color and expansion of the damaged area within approximately 13 weeks.

Left: greater expansion and darker color of the damaged area

Right: lower expansion and lighter in color after 13 weeks

Areas with extremely high penetration (damaged areas) showed discolorations of the applied mortar sludge in different size and intensity. These were arising because of the process of crystallization and are therefore completely harmless. The discolorations are reducing in the course of time, they might remain visible, but permanently dry – their appearance is of no significance (see photo 6).

The measured surface moisture of light and dark areas of the pit-wall showed no differences. To meet higher optical requirements it is basically possible to remove the backing layer completely after four weeks, as there has already been a self-sealing process of the construction by advanced crystallization.
